REEVALUATION OF THE SEISMIC PERFORMANCE OF UPPER SAN FERNANDO DAM USING UNDRAINED SHEAR STRENGTH

Phu Huynh, Mark Schultz and Wallace Lam

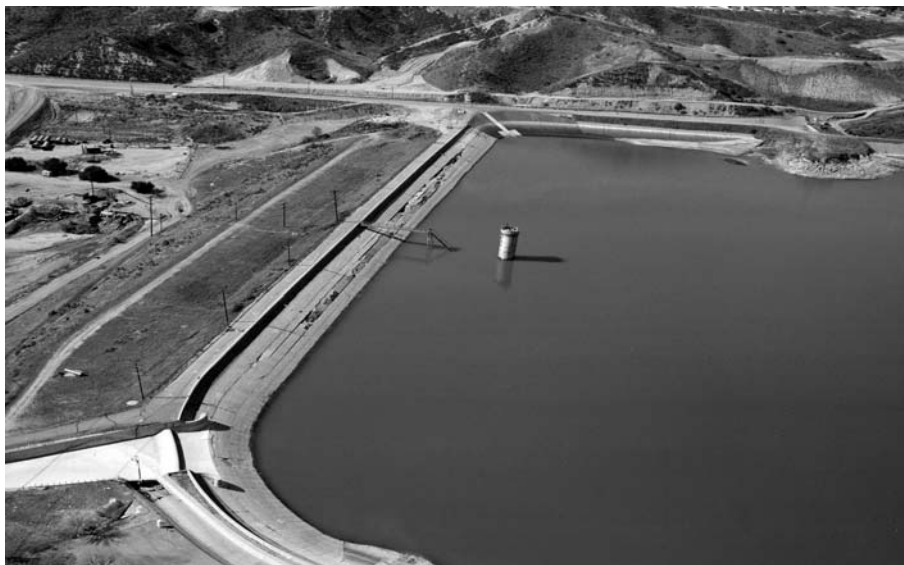
Figure 3: Post-earthquake Aerial View (Dept. of Water Resources)

The spillway was located on the left abutment with crest elevation of 1212.5 feet, providing 5 feet of freeboard. A 3.5-foot high parapet wall was added in 1935 to provide additional freeboard. The aerial view shown in Figure 3 illustrates the major components of the dam, and the extent of longitudinal cracking on the upstream face. The cracked zone thickness was used to calculate the shear zone thickness for the yield function.

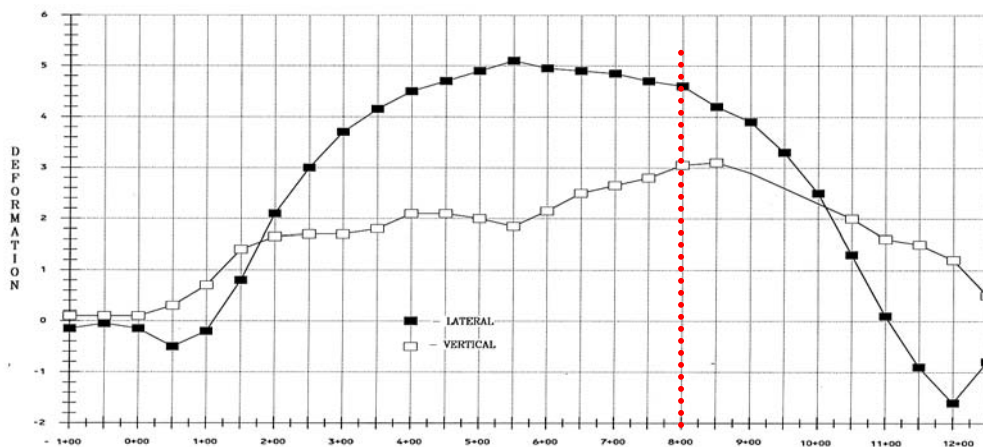
The San Fernando Earthquake was assigned a Richter Magnitude of 6.6, with the epicenter located at a distance of about 8 miles northeast of Upper San Fernando dam. A regional map of the dam is shown in Figure 11. The deformed shape of the embankment, based on crest surveys after the earthquake, is shown in Figure 12.

Figure 12: Horizontal deformation survey along dam crest

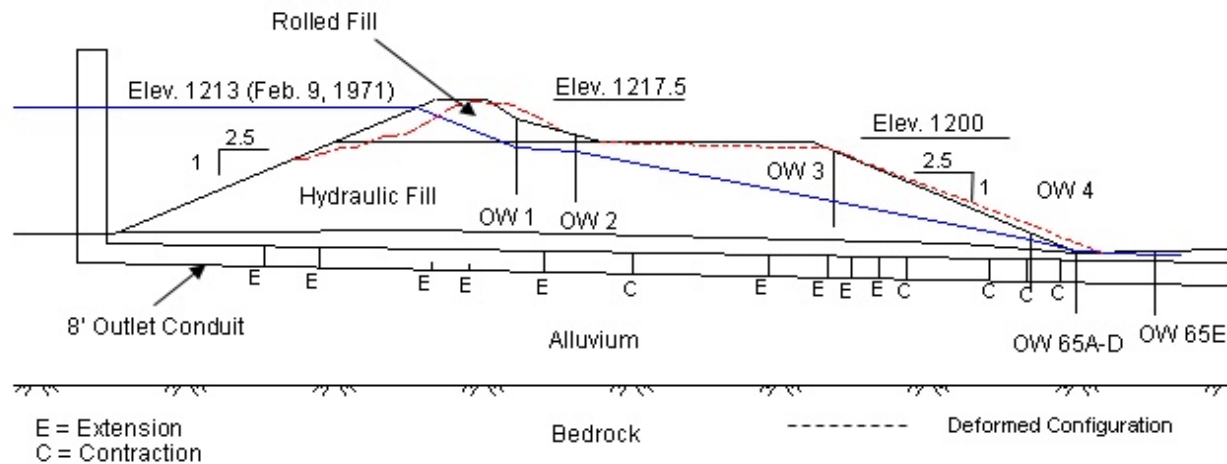
The cracking of the outlet conduit, shown in Figure 13, is an indication that only minor shearing occurred at this depth, which was therefore the lower portion of the shear zone.

Summing the observed cracking of the conduit downstream of Sta. 83+65 results in a total displacement of 0.2 ft. Therefore, the 4.6 ft of downstream shearing occurred mostly above this depth.

Figure 13: Axial Stress Pattern in Outlet Conduit

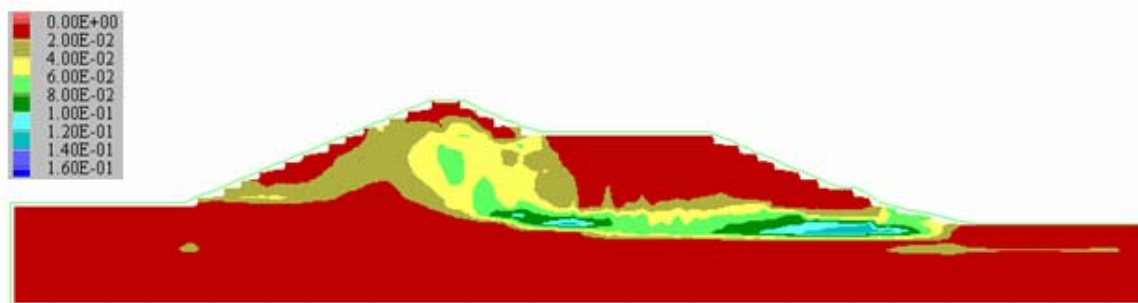
FLAC analyses were performed using the same three acceleration time history records as the foregoing yield function method. Figure 14 shows that, during shaking, a distinct shear zone is formed in the upstream and downstream slopes, and that displacements occur along these shear zones. Minor shearing also occurred in the foundation, particularly below the downstream slope of the dam.

Figure 14: Maximum Shear Strain (Mod. Pacoima Record)

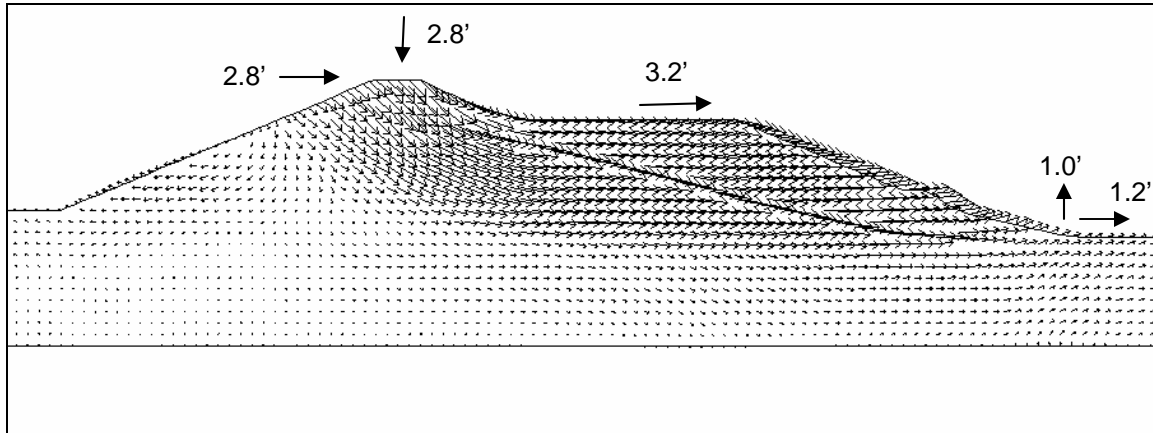
A plot of displacement vectors from the FLAC model is shown in Figure 17 for the modified Pacoima Dam Abutment time history. The displacements computed by FLAC for the three time history records are summarized in Table 5. The downstream bench moved downstream as a block. FLAC shows more complex deformation at the crest due to the combined upstream and downstream shear zones. The net displacement is downstream, but it is under-predicted due to upstream shearing. The average vertical deformation at the crest, calculated with the FLAC model, is within 1/2 ft of the observed displacement. Overall, the FLAC analyses match the observed performance reasonably well.

Figure 17: Displacement Vectors (Mod. Pacoima record)
